NATIONAL TRANSPORTATION SAFETY BOARD

MATERIALS LABORATORY FACTUAL REPORT

Report No. 06-021

Place : Lake George, New York
Date : October 2, 2005
Vehicle : Small passenger vessel "Ethan Allen"
NTSB No. : DCA06MM001
Investigator : Brian Curtis

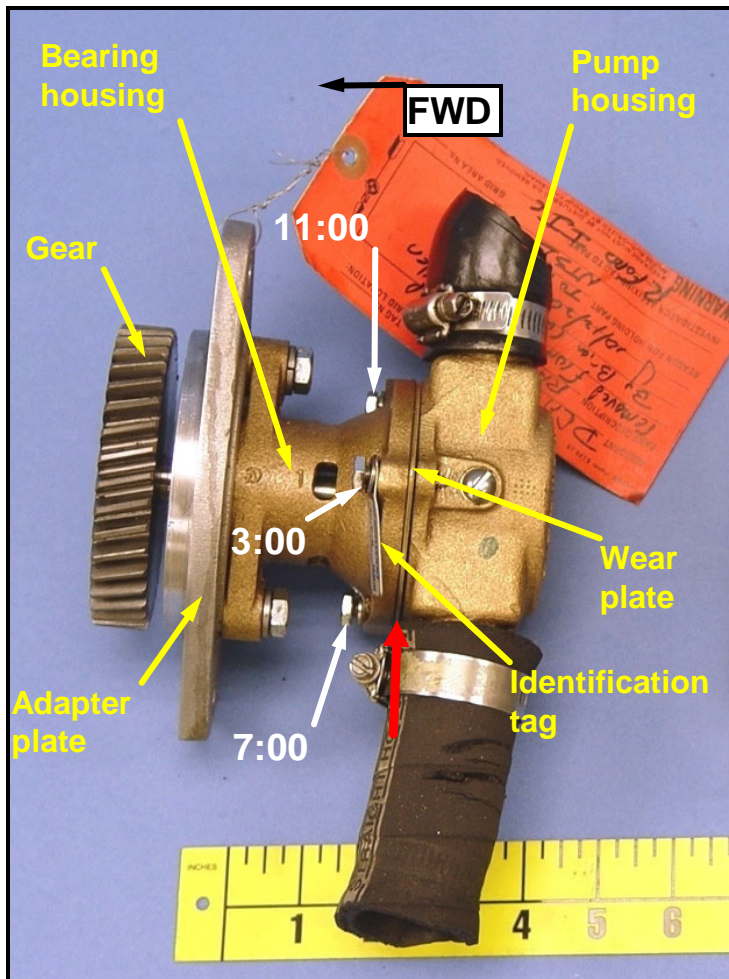
The raw water pump removed from the engine, after the vessel had been recovered, is illustrated in figure 1 with major components identified and the forward (FWD) direction, as installed on the engine, indicated. The identification tag indicated in figure 1 displayed the manufacturers name, "SHERWOOD", the pump part number, "M71-01-90" and the pump serial number, "05132". The tag also displayed "Division of Hypro Corporation" and the telephone number "651-766-6300". The exemplar pump had been utilized for the testing performed at Cummins Diesel and had been retained for comparative examination. The exemplar pump is illustrated in figure 12 and displayed an identification tag, similar to that on the accident pump, but with the part number "M71-01" and the serial number "05301". The previous raw water pump from the Ethan Allen was retained, found to be incomplete and is illustrated in figure 15. The accident pump reportedly replaced the previous raw water pump in July 2005.

Figure 1. The accident raw water pump received for examination.

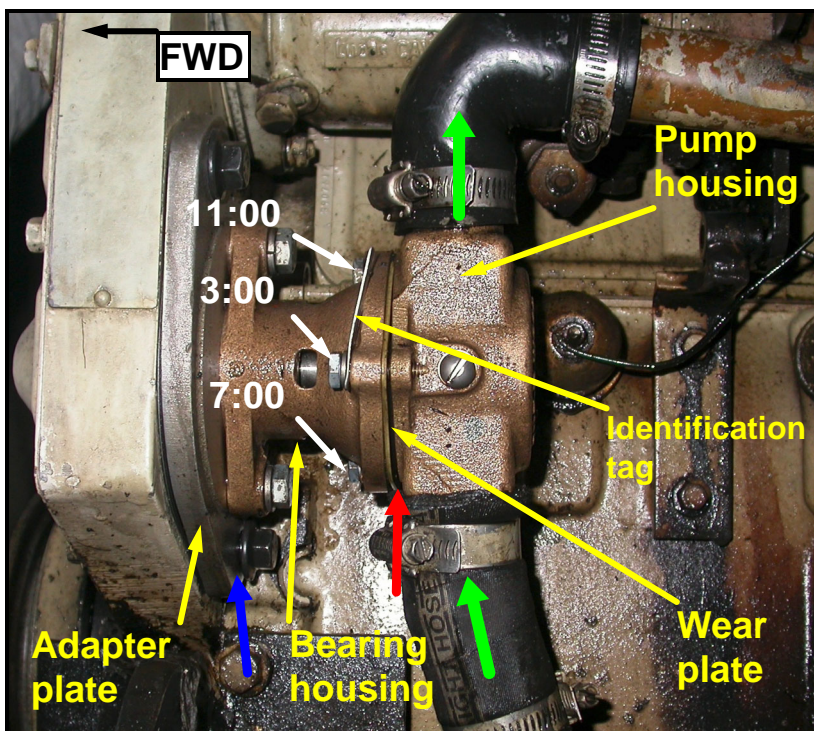
The accident pump is illustrated in figure 2 still installed on the engine after the recovery of the vessel. The major components are identified as in figure 1 with the green arrows indicating the direction of water flow through the pump. The blue arrow indicates the lower adapter plate bolt that was found loose, as illustrated. For identification purposes the three bolts securing the pump housing to the bearing housing were identified with a clock position when looking from the front of the engine. The housing bolts are identified as 3:00 (for 3 o'clock), 7:00 (for 7 o'clock) and 11:00 (for 11 o'clock) as illustrated in figure 2 (the identification is repeated in figure 1). The on-scene examination revealed the presence of a gap between the pump housing and the wear plate. The gap, indicated by the red arrow in figure 2, was measured at 0.076 inch at that location, adjacent to the 7:00 housing bolt. During subsequent pump removal and handling the gap had been almost closed, as indicated by the red arrow in figure 1, and produced the gap illustrated under the heads of the housing bolts.

Figure 2. On scene view of the accident pump attached to the engine.

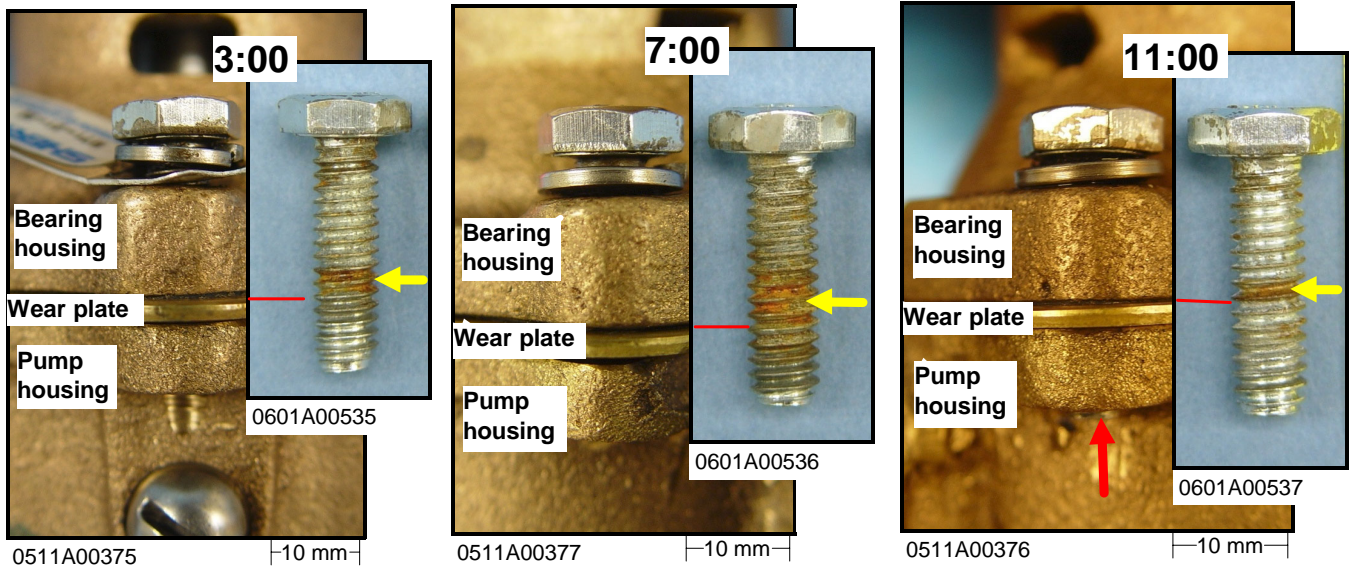
The housing bolts are inserted through holes in the bearing housing, through holes in the wear plate, and screwed into matching threads in the pump housing. Lock washers are installed between the bolt head and the bearing housing. The three bolted attachments are illustrated and identified in the three views of figure 3 with an insert view of the bolt, at a similar scale, after it had been removed. Examination of the bolts, as installed, revealed that the gap between them and the bearing housing was sufficient to allow the lock washer to rotate freely. The examination also revealed that the 3:00 and the 7:00 bolts did not penetrate through the thread in the pump housing whereas the 11:00 bolt did penetrate slightly, as indicated by the red arrow in the right view of figure 3.

The housing bolts were removed for examination. The threads displayed the onset of corrosion, indicated by the yellow arrows in the inserts of figure 3. The corrosion appeared to start at the location of the wear plate, as indicated by the red line in each insert view, and continued towards the head of the respective bolt. The 3:00 bolt displayed corrosion that encompassed approximately two threads, the 7:00 bolt displayed corrosion that encompassed approximately 3 threads and the 11:00 bolt displayed corrosion that encompassed approximately one thread. The flanks of the threads did not display any distinct smearing normally associated with the bolt being torque loaded.

Figure 3. The 3:00, 7:00 and 11:00 housing bolts on the accident pump, as received, with an insert of the bolts (after removal) at a similar magnification.

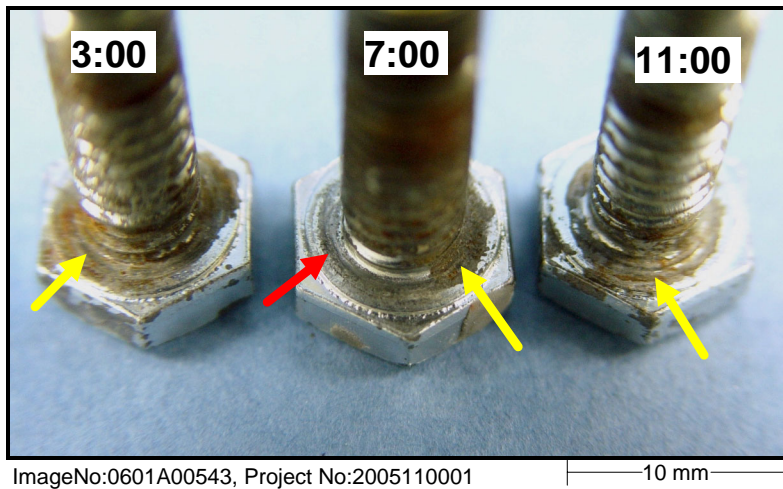
The examination of the housing bolts also revealed that plating had been removed from the underside of the head, on the shouldered face normally in contact with the lock washer. The undersides of the housing bolt heads are illustrated and identified in figure 4

with the areas devoid of plating indicated by the yellow arrows. The red arrow on the contact face of the 7:00 bolt indicates a circumferentially oriented smearing of the remaining plated surface.

Figure 4. The lock washer contact faces on the accident pump housing bolts.

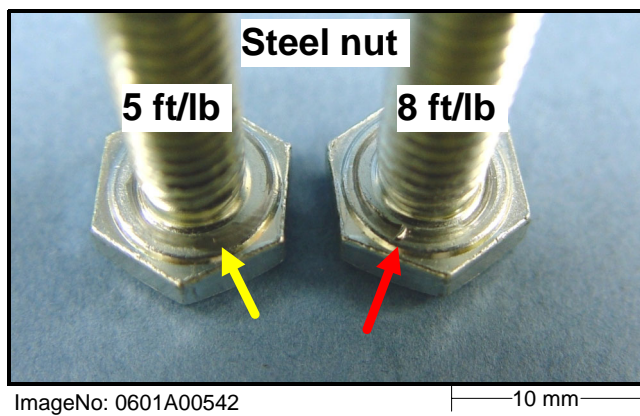
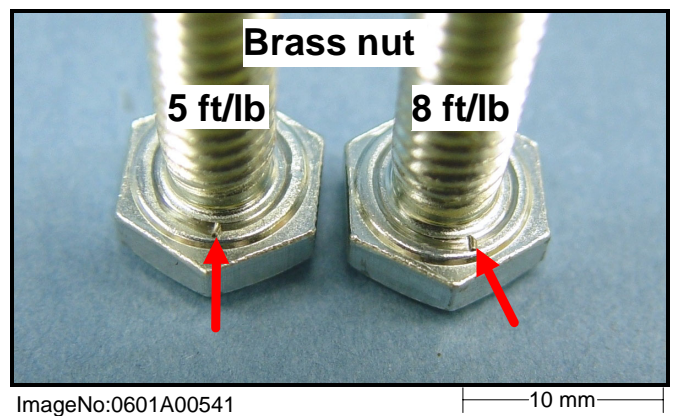
Lock washers of the type utilized with the housing bolts are commonly referred to as helical spring lock washers. When a helical spring lock washer is compressed during a bolt tightening operation, the contacting faces slide over each other. When the bolt is loosened the sharp edge of the lock washer digs into the contacting faces to leave a distinct impression that displays the orientation of the sharp edge. With softer materials, the sharp edge of the lock washer can dig a trough and displace material forward to leave a distinctly straight roll of material on those faces. To determine if this would occur with the housing bolts and lock washers, a test was performed after completion of the examination. Exemplar bolts and lock washers, supplied by the pump manufacturer, were individually assembled and torque loaded to 5 foot-pounds and 8 foot-pounds (the lower and upper limits specified by the pump manufacturer), then loosened. The left view of figure 5 illustrates the contact faces of two exemplar bolts that were torque loaded at 5 foot-pounds and 8 foot-pounds using a steel nut as a substitute for the threads in the pump housing. The yellow arrow indicates a small roll of material barely visible on the contact face of the bolt loaded at 5 foot-pounds and the red arrow indicates a distinct roll of material on the contact face of the bolt loaded at 8 foot-pounds. The test was repeated using a brass thread (one of the pump housing threads). The results are illustrated in the right view of figure 5 where the red arrows indicate distinct rolls of material on the contact faces of both bolts. Material deformation similar to that created on the exemplar bolts was not found on any of the three bolts from the accident pump.

Figure 5. The lock washer contact faces on the exemplar bolts torqued into a steel nut (left) and into a brass nut (right) at the torque values indicated.

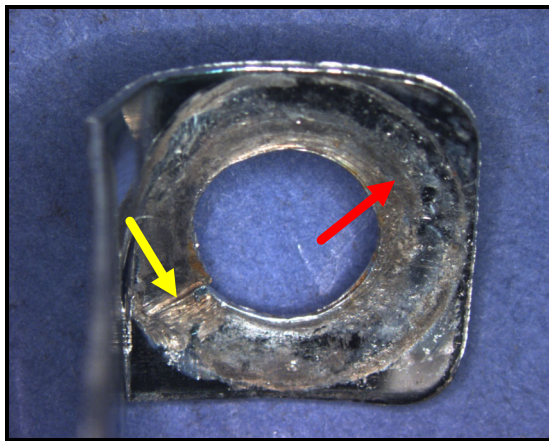
The lock washer contact faces on the bearing housing were then examined. The lock washer for the 3:00 bolt was in contact with the identification tag, as illustrated in figures 1, 2 and in the left view of figure 3. Examination of the contact face on the identification tag revealed the distinct surface indentation indicated by the yellow arrow in the left view of figure 6 and the circumferential smearing indicated by the red arrow. The indentation displayed the trough and roll features consistent with the loosening of a bolt and lock washer previously described. The angular location of the impression matched the angular location of the edge of the lock washer. Manipulation of the tag suggested that it had been manufactured from a very soft aluminum. The contact face around the hole in the bearing housing displayed the slight flattening of isolated locations on the dimpled surface, indicated by the red arrows in the right view of figure 6. The blue arrow in the right view indicates a shallow straight-line feature that displayed rounded contours and was at the wrong orientation to have been produced by a helical spring lock washer.

Figure 6. The lock washer contact face on the identification tag at the 3:00 housing bolt (left) and the contact face on the bearing housing below the tag (right).

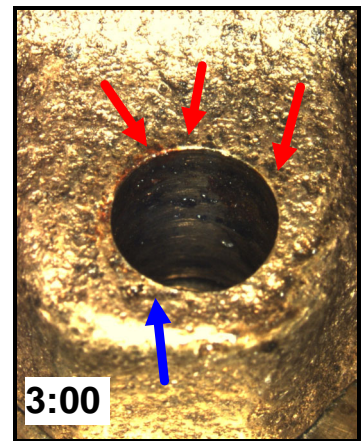
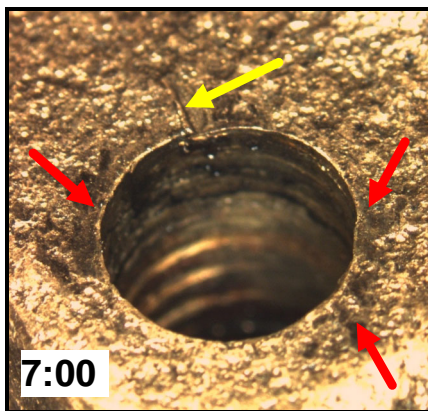
The lock washer for the 7:00 bolt would normally be in contact with the bearing housing surface illustrated in the left view of figure 7. The yellow arrow indicates a distinctive straight indentation, with material forced forward in the direction indicated by the arrow, which could be produced by the loosening off of a helical spring lock washer. The red arrows indicate a slight flattening of isolated locations on the dimpled surface.

The spring washer for the 11:00 bolt would normally be in contact with the bearing housing surface illustrated in the right view of figure 7. No distinctive indentation was observed, and the red arrows indicate a slight flattening of isolated locations on the dimpled surface.

Figure 7. The bearing housing contact faces for the 7:00 lock washer (left) and for the 11:00 lock washer (right).

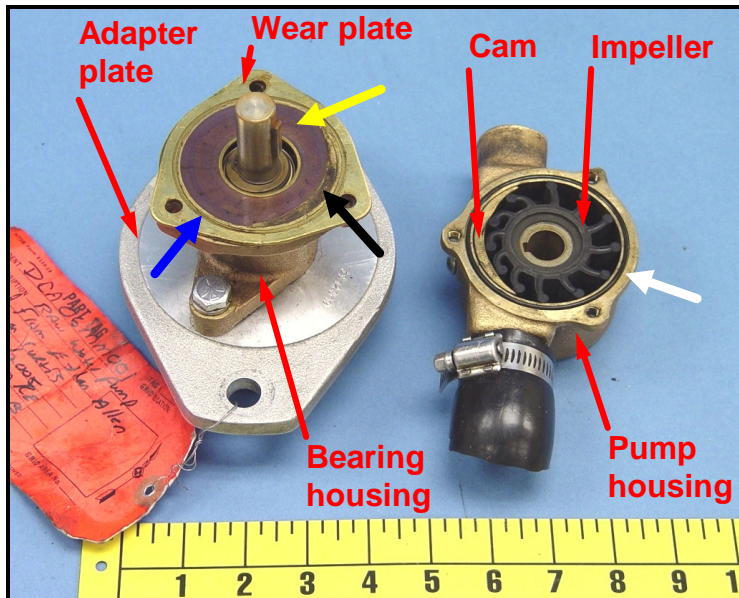
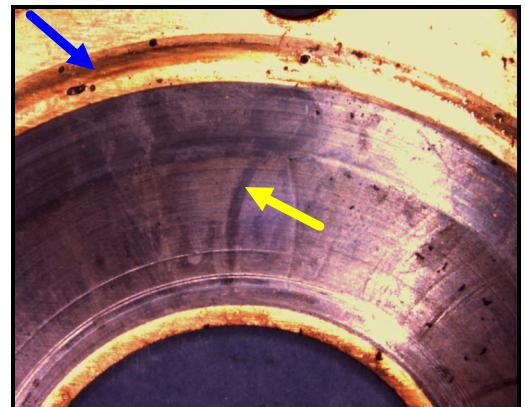
The partially disassembled pump is illustrated in the left view of figure 8 with the major components identified. The impeller is illustrated in the pump housing and has five of its lobes in contact with the cam, illustrating the pumping action previously described. The black arrow on the wear plate indicates the profile of the cam. The white arrow on the pump housing indicates the o-ring that seals the housing to the wear plate, and the blue arrow indicates a well defined imprint of the o-ring on the wear plate, indicative of a good all-round contact. The o-ring was removed from the pump housing and was found to have retained its round cross-section. The yellow arrow indicates the discolored surface of the wear plate, normally contacted by the side of the impeller illustrated in the pump housing. A closer view of the discolored surface on the wear plate is illustrated in the right view of figure 8 with a yellow arrow indicating one of the numerous imprints of an impeller lobe. The blue arrow indicates the o-ring imprint indicated by the blue arrow in the right view.

Figure 8. The accident pump partially disassembled (left) and a closer view of the discolored impeller contact face on the wear plate (right).

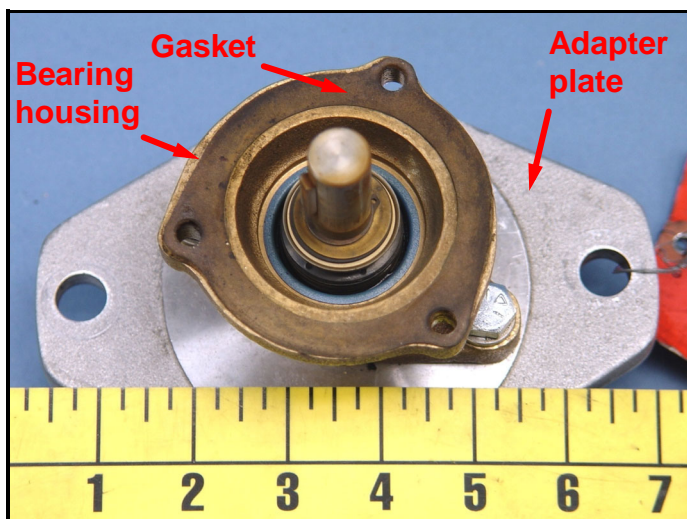
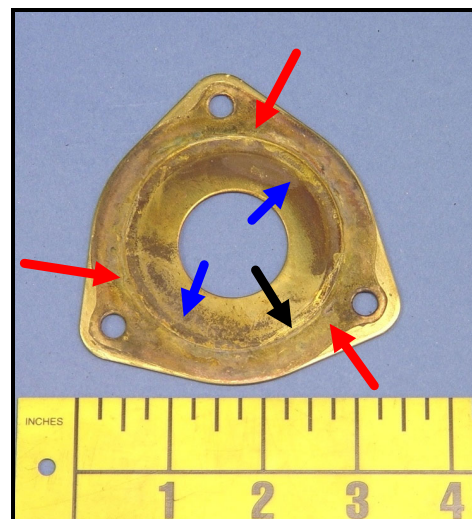
The wear plate was removed to reveal a gasket between it and the bearing housing. The gasket remained on the bearing housing and is illustrated and identified in the left view of figure 9. The mating face of the wear plate is illustrated in the right view of figure 9 and displayed a matching imprint of the gasket, indicated by the red arrows, consistent with a good all-round contact. The circle indicated by the black arrow is an imprint of the inner diameter of the gasket, and the blue arrows indicate discoloration on the wear plate surface located inside of that circle.

Figure 9. The gasket between the bearing housing and the wear plate (left) and the impression it left on the wear plate (right).

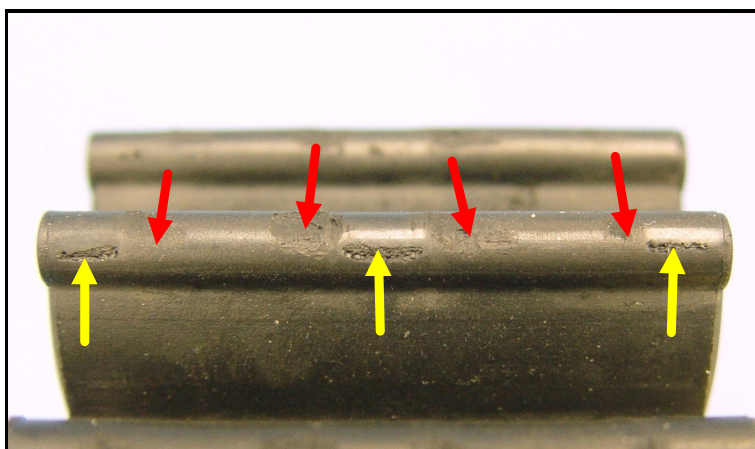
The impeller was extracted from the pump housing and examined. The examination revealed that the impeller was a dark gray color and displayed two distinct types of wear at the tip of each lobe. A typical lobe is illustrated in figure 10 with yellow arrows indicating three narrow bands of wear at the tip of each lobe. The narrow bands are located where the lobe initially contacts the three fingers of the cam (the three fingers on one end of the cam are indicated by the blue arrow in figure 12 and allow the entry and exit of water for the pumping action previously described). The four red arrows indicate wear that was deeper adjacent to the cam finger contact locations and tapered off as the distance from those locations increased.

Figure 10. Typical wear patterns on one lobe of the accident pump impeller.

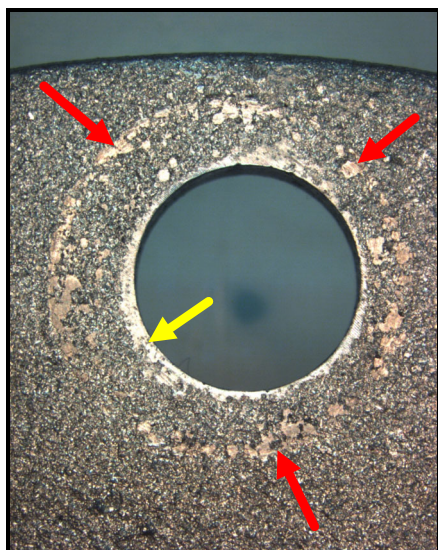
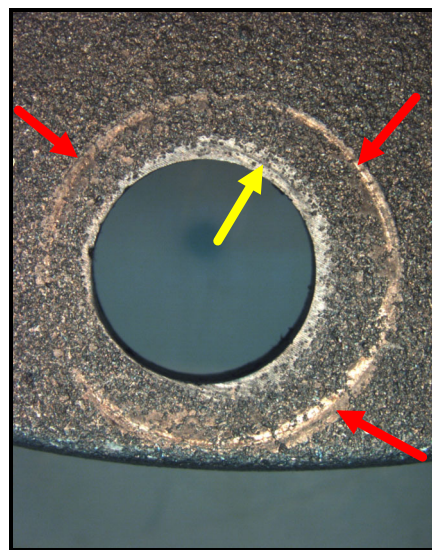
The shoulder on the forward face of the adapter plate is illustrated in figure 1 and locates the plate on the engine. The adapter plate is normally secured to the engine by two bolts with heads consisting of a hexagonal portion and a round portion. As illustrated in figure 2, the upper bolt appeared to be in contact with the adapter plate and the lower bolt, indicated by the blue arrow, appeared to be loose. Examination of the bolt holes in the adapter plate revealed contact marks on both. The upper and lower bolt holes are illustrated in the left and right views of figure 11 respectively, with a red arrow indicating the outer diameter of the washer portion of the bolt head and a yellow arrow indicating contact by the radius located between the washer portion of the head and the shank of the bolt.

Figure 11. Contact marks on the upper (left) and lower (right) mounting holes of the accident pump adapter plate.

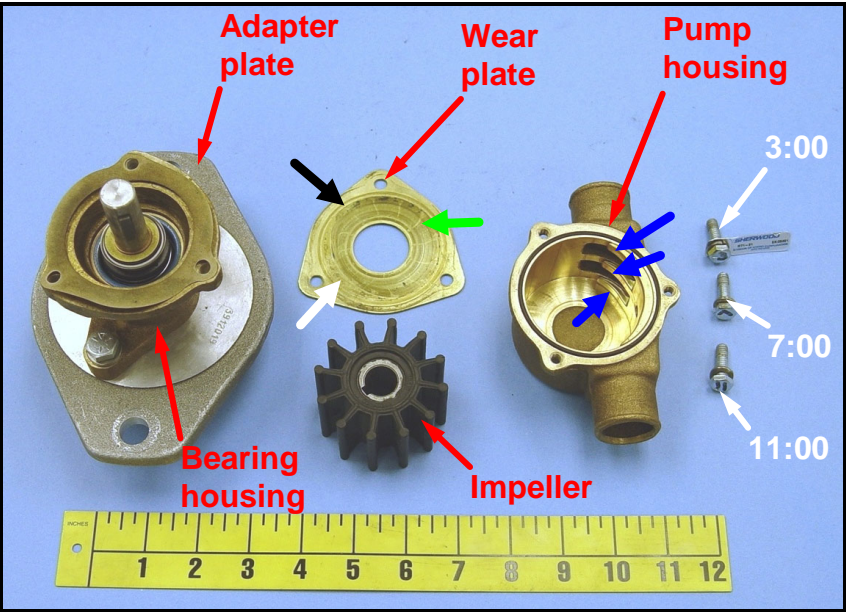
The exemplar (test) pump was disassembled and is illustrated in figure 12 with the major components identified (the housing bolts were already loose following the testing). The housing bolts were also identified by their clock position as seen from the front of the engine.

The pump housing was examined and, as illustrated in figure 12, was found to display negligible signs of usage. The o-ring was extracted from the pump housing and examined. The examination found it to be intact, with no tears, cuts or missing material, and that it had retained its round cross section.

The impeller side of the wear plate displayed a well defined imprint of the o-ring, indicated by the black arrow in figure 12, and the other side displayed a well defined imprint of the gasket. The impeller side also displayed a dark discoloration and light circumferential marks, indicated by the green arrow in figure 12, consistent with contact by the impeller and a relatively unmarked area, indicated by the white arrow in figure 12, that matched the profile of the cam. A closer examination of the discoloration revealed that it consisted of particles of a similar color as the impeller and manipulation of larger particles revealed that they were elastomeric.

Figure 12. The partially disassembled test pump.

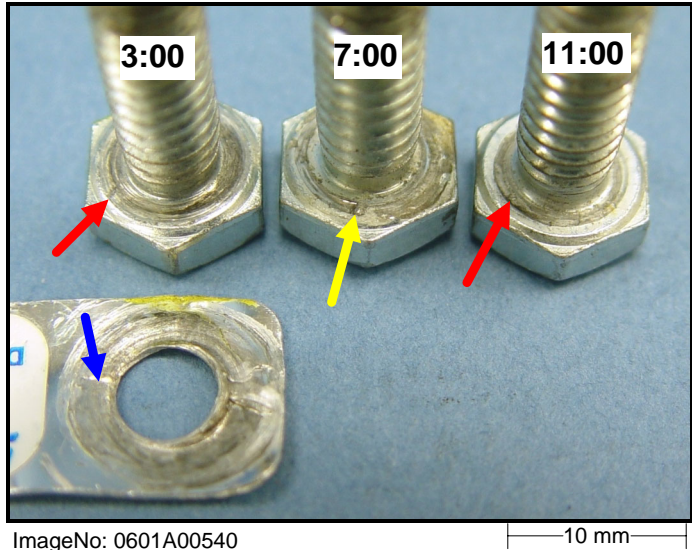
The lock washer contact faces on the housing bolts are illustrated in figure 13 with red arrows indicating small rolls of material on the contact faces of the 3:00 and 11:00 bolts and the yellow arrow indicating a more distinct roll of material on the contact face of the 7:00 bolt. Plating had been removed from all three of the lock washer contact faces and displayed a circumferential orientation consistent with the sliding action of a contact face on a lock washer during a tightening operation. The lock washer contact face on the identification tag is also illustrated in figure 13 with the blue arrow indicating an indentation, similar to that on the identification tag on the accident pump and consistent with contact by the sharp edge of the lock washer during a loosening operation.

Figure 13. The lock washer contact faces on the test pump housing bolts with their clock position indicated.

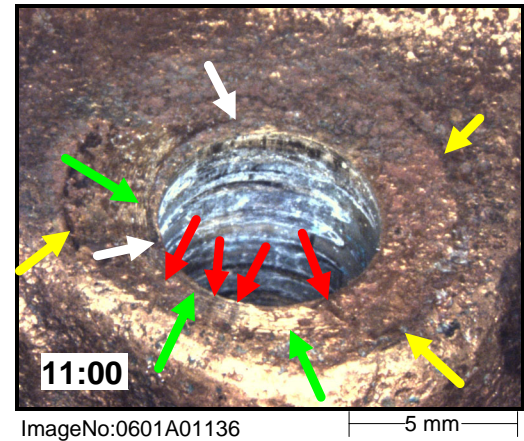
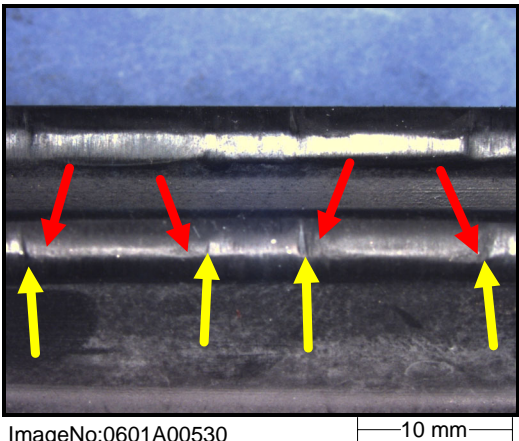
Examination of the lock washer contact face at the 3:00 location on the bearing housing revealed flattening of prominent surface dimples and a white metal deposited in isolated recesses, consistent with it being the location of the identification tag. The contact face at the 7:00 location displayed the flattening of prominent surface dimples, circumferential scratches and an indentation that would match the edge of the lock washer. The lock washer contact face at the 11:00 location is illustrated in the left view of figure 14 and displayed flattening of prominent surface dimples, indicated by the yellow arrows, circumferential scratches, indicated by the green arrows, multiple indications of indentations produced by the sharp edge of the lock washer, indicated by the red arrows.

Examination of the impeller revealed that it consisted of a black elastomeric material and displayed indentations and wear at the tip of each lobe, consistent with contact with the cam fingers. The yellow arrows in the right view of figure 14 indicate indentations from the edges of the fingers of the cam. The red arrows indicate areas of wear that correspond to the body of the cam contacted by the impeller after it had traversed the fingers.

Figure 14. Lock washer contact face at the 11:00 position on the test pump bearing housing (left) and typical wear on a lobe of the test pump impeller (right).

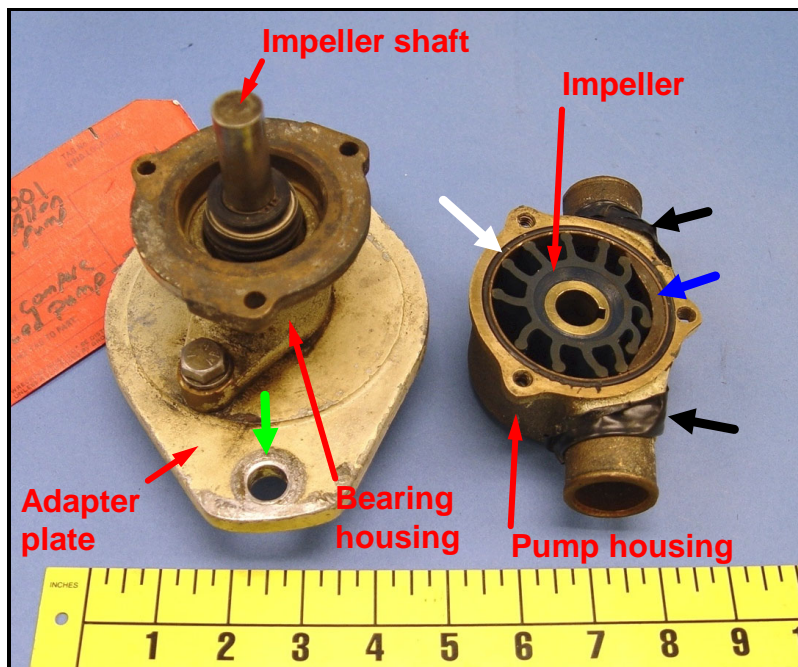
The previous pump was received with the pump housing attached to the bearing housing by electrical tape. The adapter plate was still bolted to the bearing housing but there were no housing bolts or a wear plate. The tape was cut and the housings separated. The separated housings are illustrated in figure 15 with the major components identified.

The impeller was extracted from the pump housing and an examination of the impeller cavity in the pump housing revealed a uniformly dull brown surface, similar to the color on the side of the cam and indicated by the blue arrow in figure 15. The flat surface did display light circumferential marks indicative of contact by a rotating impeller and imprints of impeller lobes. The impeller was a dark blue color and displayed light score marks consistent with it contacting the edges of the cam fingers. A portion of a typical impeller lobe is illustrated in figure 17 with yellow arrows indicating the light score marks and a red arrow indicating where a small piece was missing from the tip of the illustrated lobe.

Significant circumferential scoring was observed around the adapter plate bolt holes, consistent with repeated bolt tightening actions. The scoring around one bolt hole is indicated by the green arrow in figure 15.

Figure 15. The previous pump components received for examination, with the pump housing separated from the bearing housing.

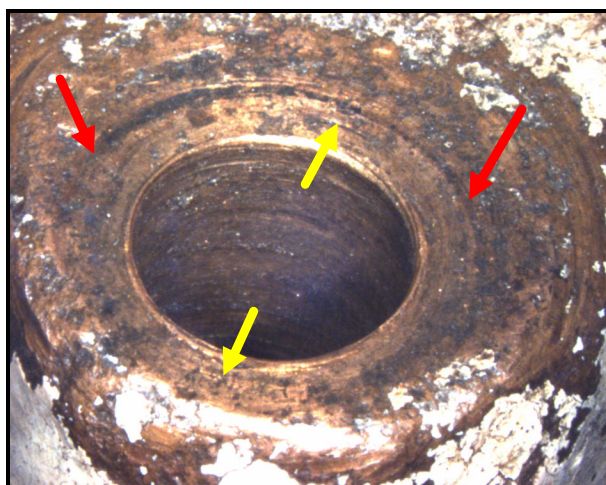
Examination of the three bolt holes in the bearing housing revealed a circular depression around each hole with circumferential scratches on its flat bottom surface, consistent with being worn by repeated applications of the housing bolts and spring washers. A typical bolt hole is illustrated in figure 16 with red arrows indicating the depression and yellow arrows indicating more prominent circumferential scratches. The diameter of the depression approximated that of the helical spring washers previously removed from the other pumps.

Figure 16. Typical features on a lock washer contact face on the bearing housing of the previous pump.

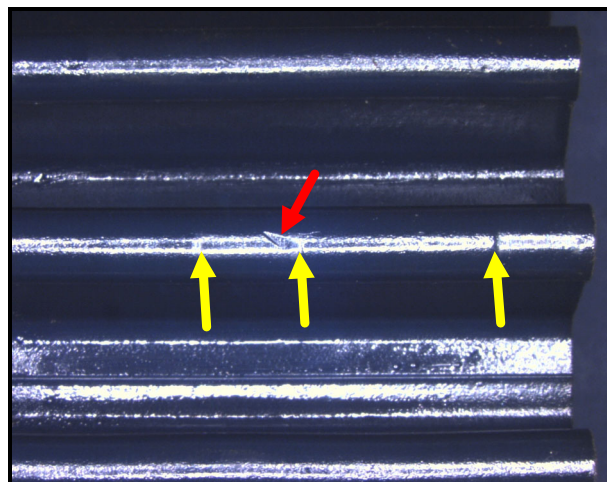
Figure 17. Typical wear marks on one lobe of the the impeller in the previous pump.
